LAKE STOCKHOLM DAM

NJ 00302

PHASE 1 INSPECTION REPORT  
NATIONAL DAM SAFETY PROGRAM

79 04 16 689  
March 1979

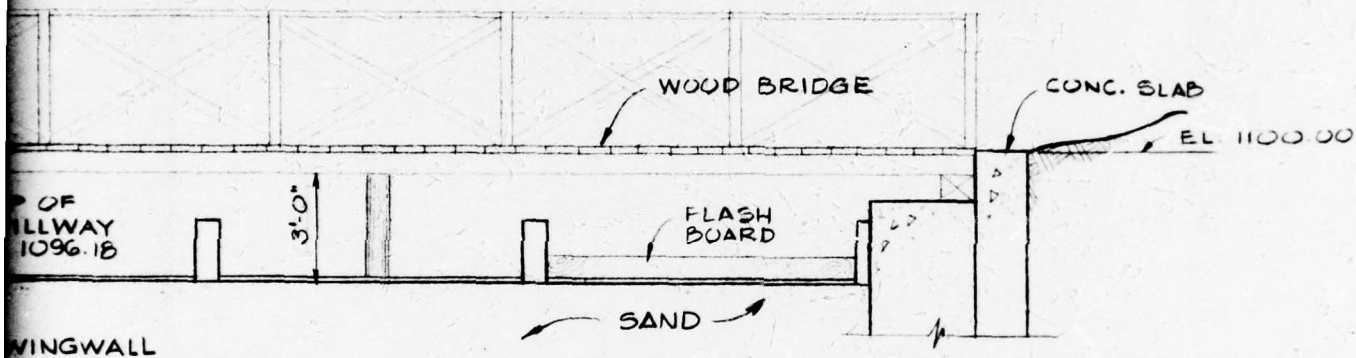
# SECTION A-A

The spillway is constructed of concrete and has a 30-ft long weir crest and appears to be founded on rock at the right abutment and has a concrete sidewall abutment at the embankment portion of the dam. A steel framed wooden bridge crosses the spillway and wooden platform extends out into the reservoir where the spillway and embankment abut. Erosion has occurred from under the platform. A concrete pad appears to have been poured relatively recently under the platform and erosion has occurred in an area about 6 inches deep by 2 ft wide along the west side of the spillway side wall. The side wall concrete has spalled and deteriorated.

9. Repair concrete of spillway side wall. This should be done in the future.
10. The spillway capacity is inadequate. We estimate the dam can adequately pass only 21% of the PMF. The SDF and the capacity of the spillway should be determined using more precise and sophisticated methods and procedures. The need for and type of mitigating measures should be determined. Around the clock surveillance during periods of unusually heavy precipitation should be provided, and a warning system established. This should be done in the near future.
